# **The Hamptons at MetroWest, a Case Study of Structural Repairs to Rot Damaged Wood Condominium Buildings**

Felix Martin

Principal Engineer, Marcon Forensics, LLC, 1278 Glenneyre, Laguna Beach, CA 92651; PH (949) 376-0290; FAX (888) 752-5580; email: felix@marconforensics.com

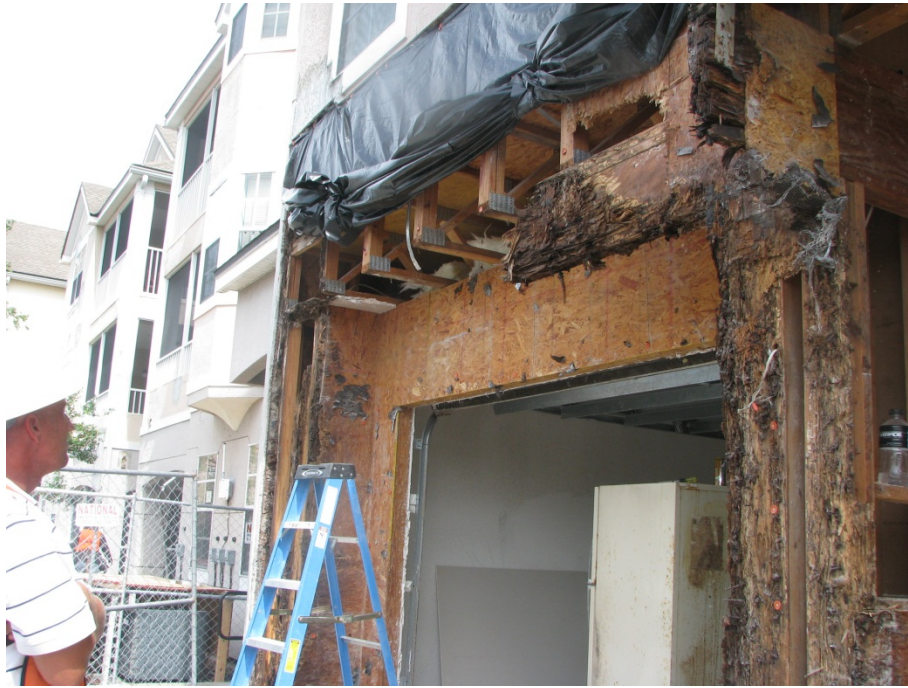
Photo #2 – Rot decayed wall framing at Building 41.

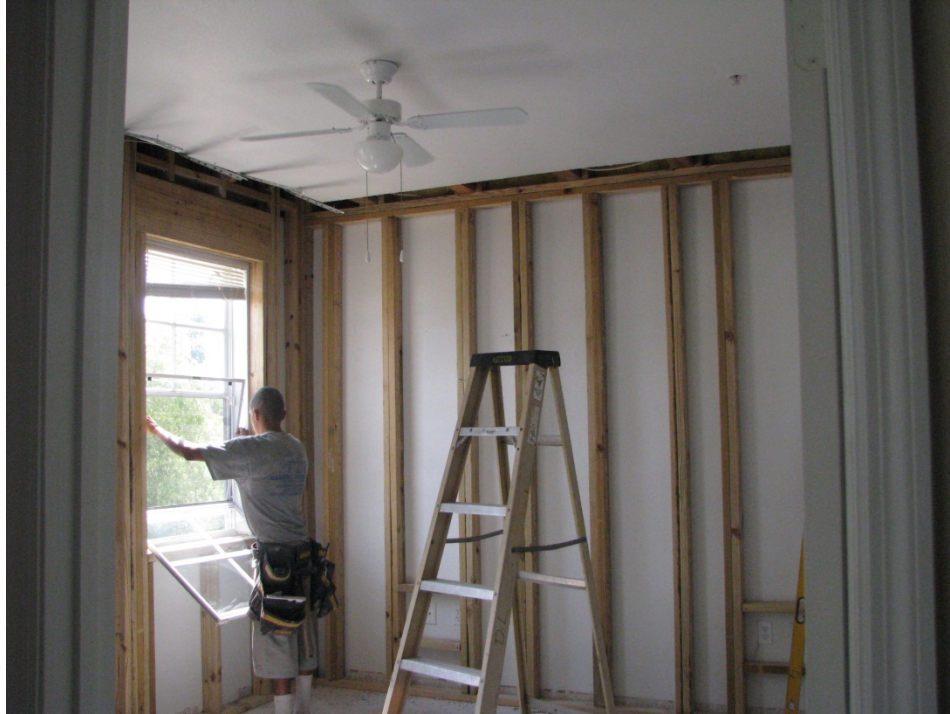
The extensive wood decay to the three and four-level exterior walls of the buildings facing the lake became problematic when they reached a damage level that was believed life-threatening. This led in 2010 to the decision to install emergency shoring under the damaged bearing walls. Because the worst decay damage occurred in the lower levels, shoring was required at the basement and first levels only. In order to control the cost of these temporary repairs and to allow continued occupancy of the units, new temporary shoring walls were built six inches inside the face of the old walls. The new walls were finished with drywall, and electrical, phone and cable outlets were relocated to the new interior wall face. This temporary shoring was relatively inexpensive (compared to a full repair, for which funds were not available), and it provided a temporary means to safely continue occupancy of the compromised units.

Photo #3 – Installation of interior shoring walls at Building 24.

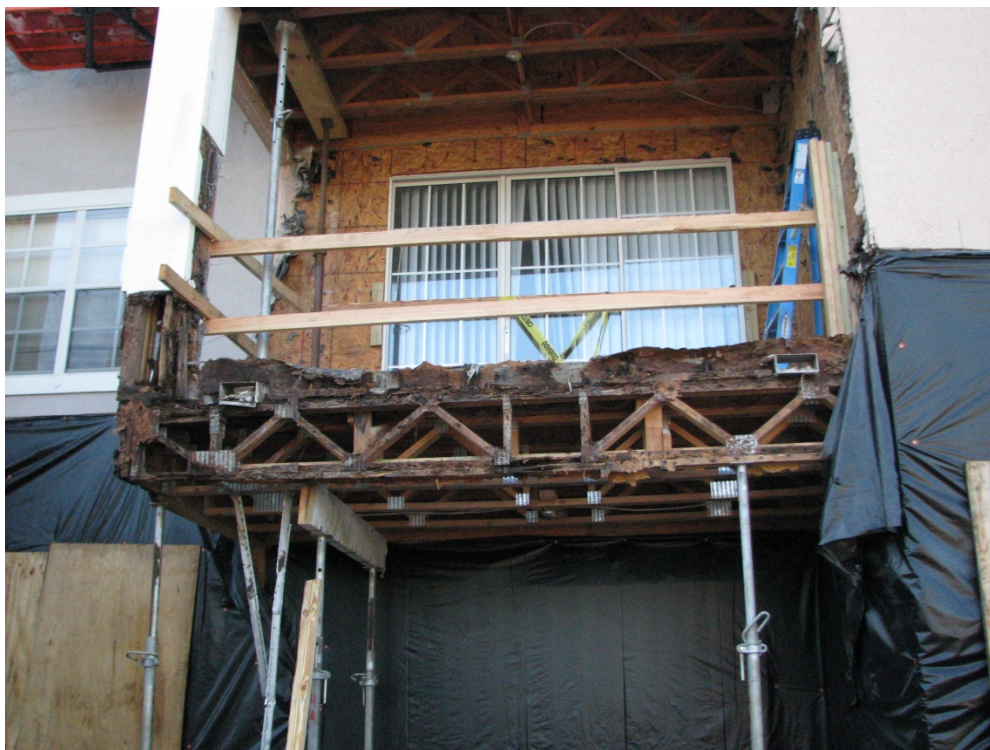
Photo #4 – Damaged balcony at Building 41.

Outside of the exterior wall repairs, the exterior balconies were estimated by Marcon to require complete removal and replacement. This estimate was based on test results and the full emergency replacement of some balcony stacks that had already taken place.

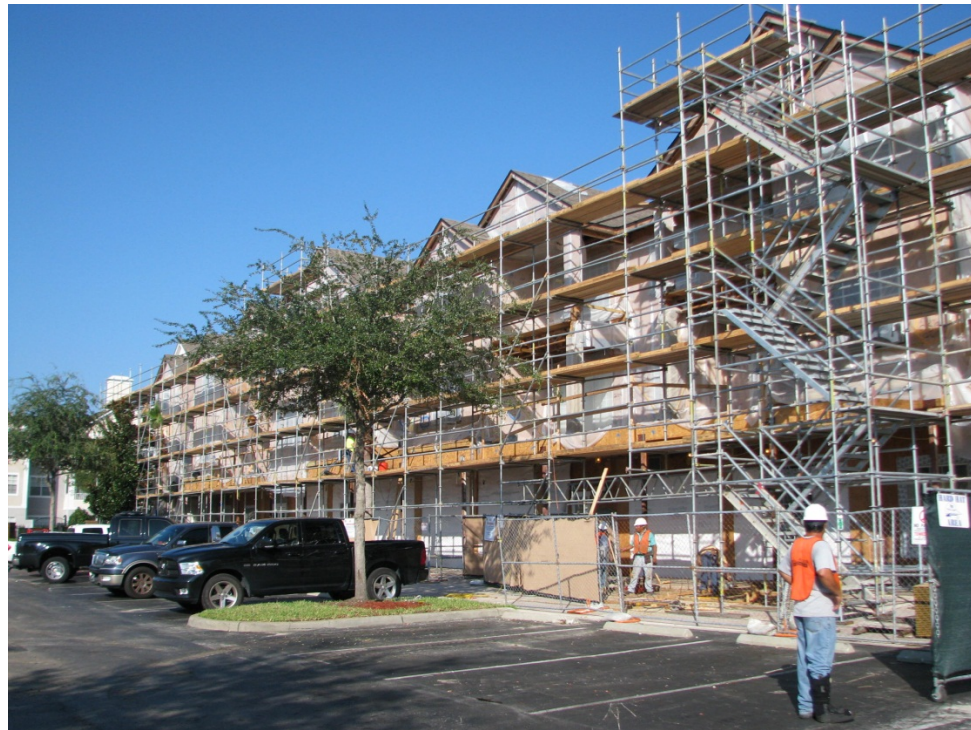
Photo #5 – Repair scaffolding.

The repairs were designed to be done in unit stacks. Scaffolding would be erected, and removal of stucco would begin on a vertical stack of units. Once that was completed, repairs would commence on that stack, while the stucco removal crew would move to the adjoining unit stack. Once the removal and replacement of windows and damaged lumber was completed, that crew would move to the adjoining stack, while a new crew installed new flashing and new stucco. As the work progressed, work teams would move around the building, demolishing, removing and replacing, and finally finishing.
